**Report to the  
Township of Madawaska Valley  
for the Condition Assessment of  
the Wastewater Treatment  
System**

Ontario Clean Water Agency  
2085 Hurontario Street, 5<sup>th</sup> Floor  
Mississauga, ON L5A 4G1

Date: December 9, 2020

Project No: MADVAY5979-2023

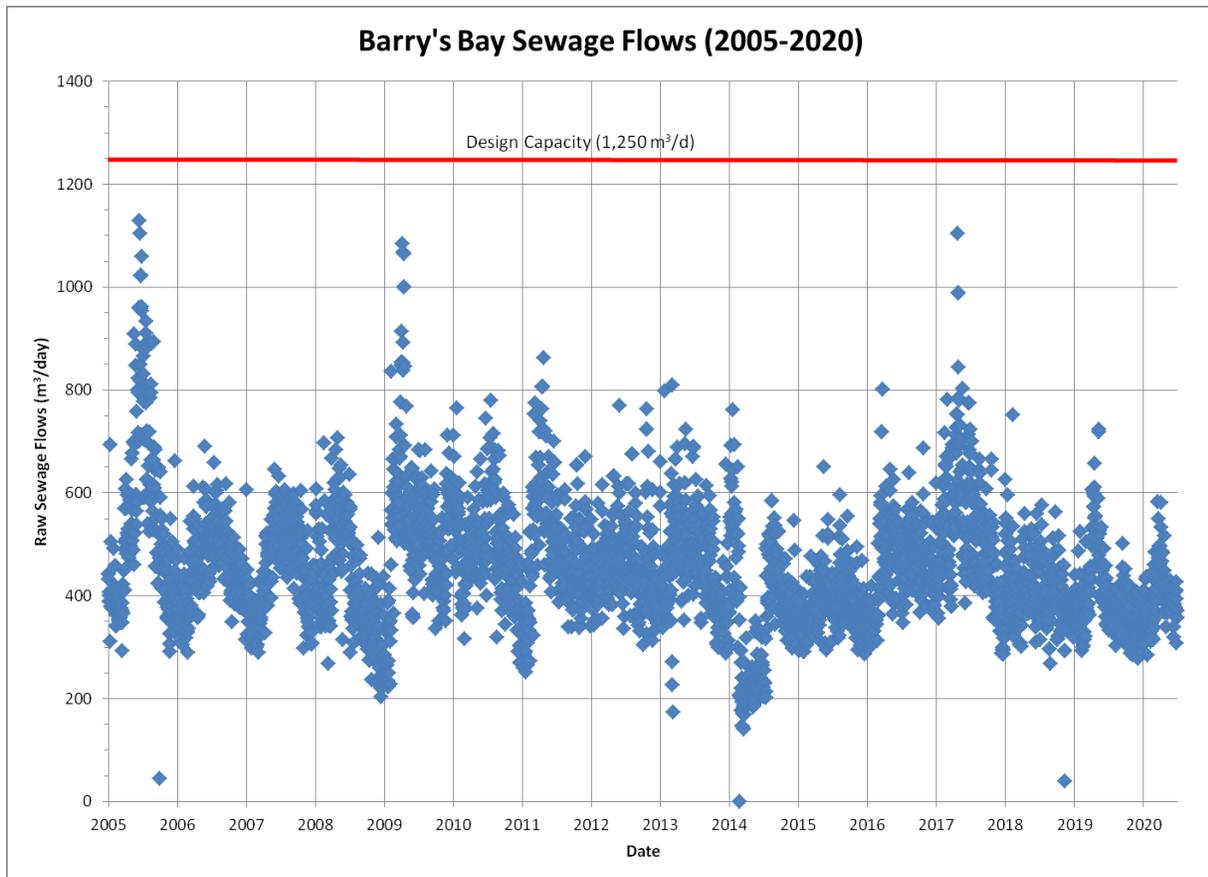
Figure 1: Barry’s Bay Sewage Flow History (2005-2020)

Figure 1 shows the wastewater flow in comparison to the plant’s rated capacity. The average flow over the 15-year period is 450 m<sup>3</sup>/day, while the plant has a capacity to treat 1,250 m<sup>3</sup>/day. Peak flows of up to 1128 m<sup>3</sup>/d have occurred very infrequently over this period.

To assess the present capacity to treat sewage flows, the last 15 years of daily treated water flows were compiled from OCWA’s WISKI process database.
