Barry's Bay Drinking Water System

2019 Annual Water Report

Reporting period of January 1, 2019 – December 31, 2019

Prepared For: The Madawaska Valley Township

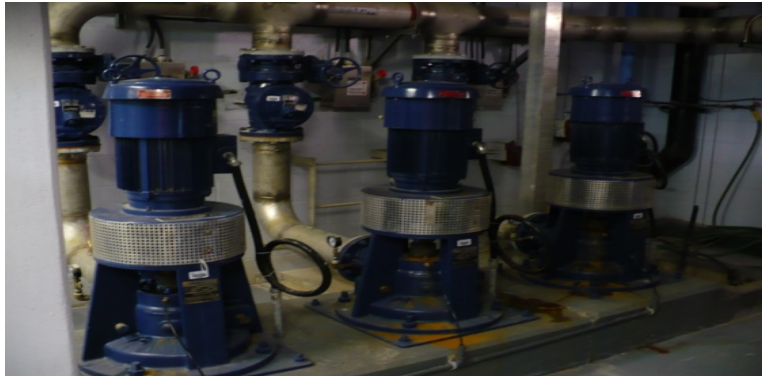
Raw Source

Raw water source for the Barry’s Bay Drinking Water System is Kamaniskeg Lake. The water is drawn from the lake using low lift pumps.

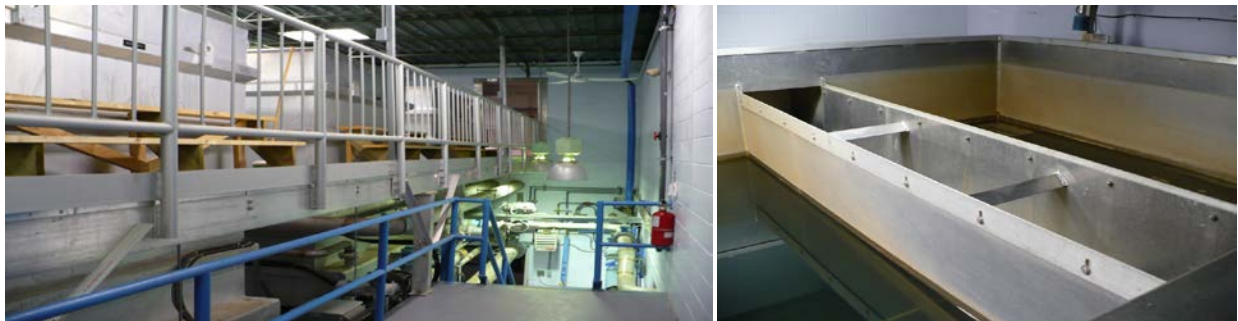
The Barry’s Bay Water Treatment Plant is a direct filtration plant. The plant utilized the coagulation, flocculation and filtration processes.

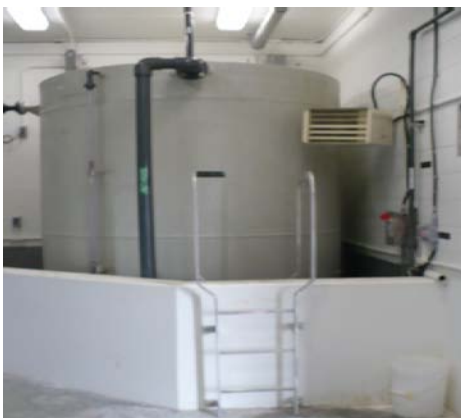
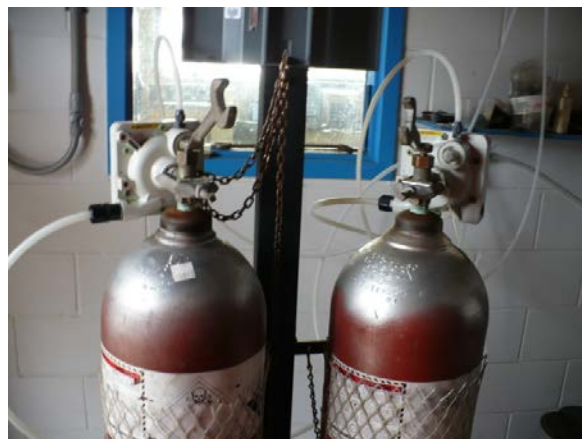
Alum is added to assist coagulation and soda ash for pH adjustment. Filter effluent is disinfected using chlorine gas before entering the clearwell.

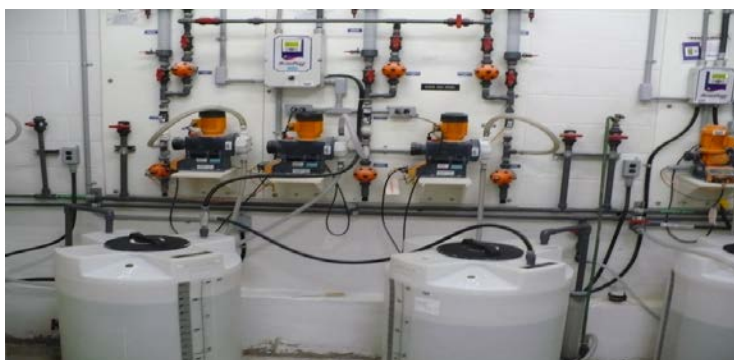
This facility has the ability to add polymer to aid flocculation and to add ammonia sulphate for chloramination but does not utilize these processes at this time.
